HO-842, House
12400 Route 108/Clarksville Pike, Clarksville
Howard County
Ca. 1900
Private

Inventory No. HO-842

Maryland Inventory of Historic Properties Form

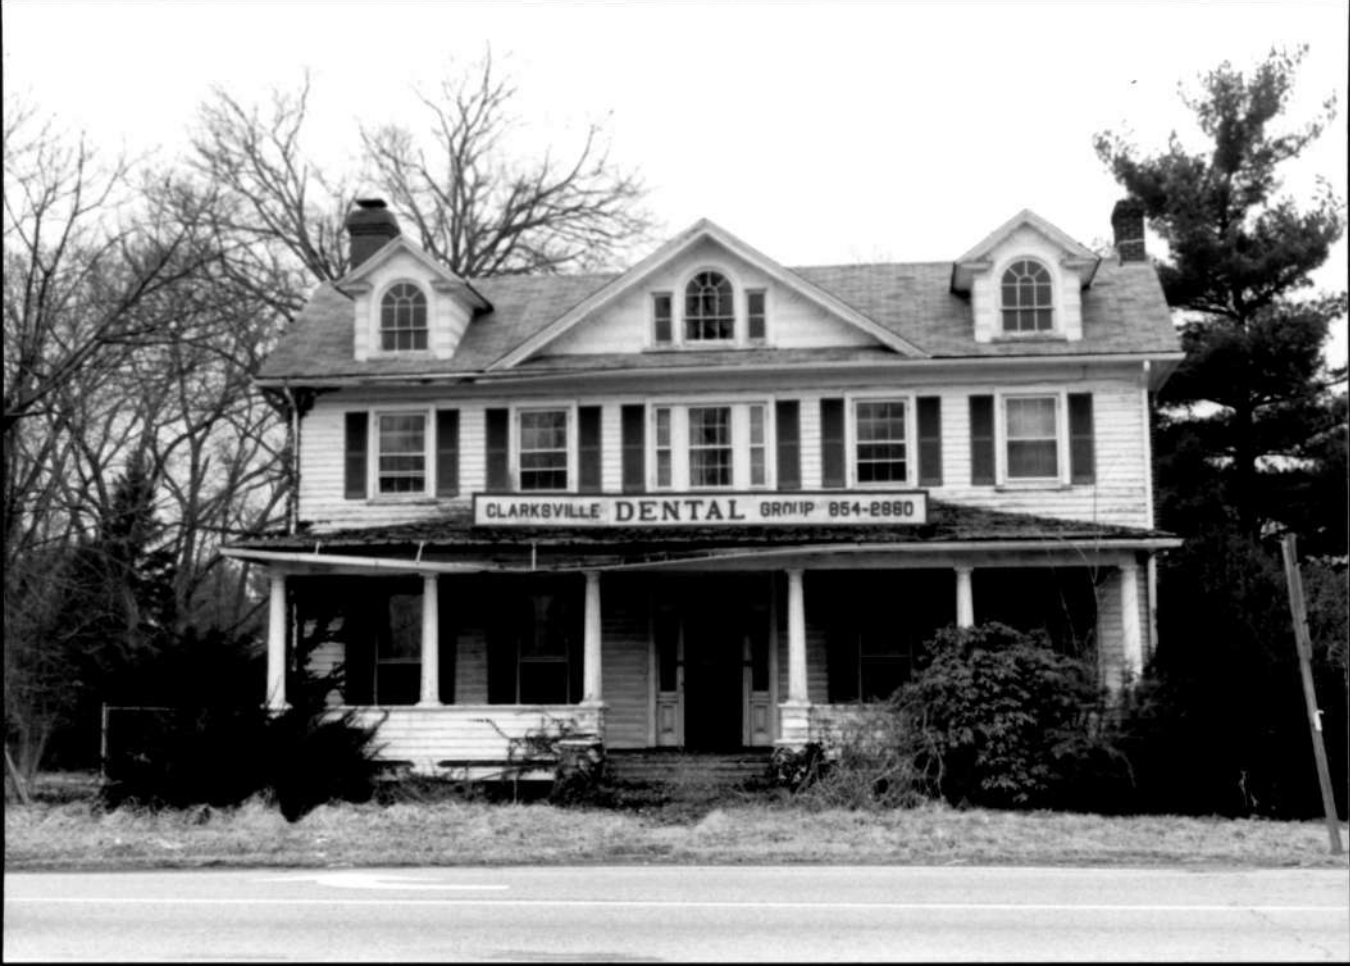
1/9

The front (east) façade is five bays wide with a central entry. The front door (now boarded over) is capped by a six-light transom and flanked by 3-light sidelights. On either side of the door there are two floor-to-ceiling 9/9 double hung wood windows. The second story features a three-part window in the center bay (a regular size 6/6 double hung window flanked by narrow 2/2 windows). The four other second story windows are double hung 6/6 sash. The second story openings are vertically aligned above the first story openings. The front slope of the roof features a central cross gable flanked by two gabled dormers. The cross gable is shingled and contains another three part window. On either side of the cross gable is a gabled dormer. Each dormer has cornice returns and holds an arched window. A full width front porch spans the front façade. The solid balustrade is covered with wood clapboards and six Doric columns rest on top of the balustrade and support the hipped roof.

Front (east) facade

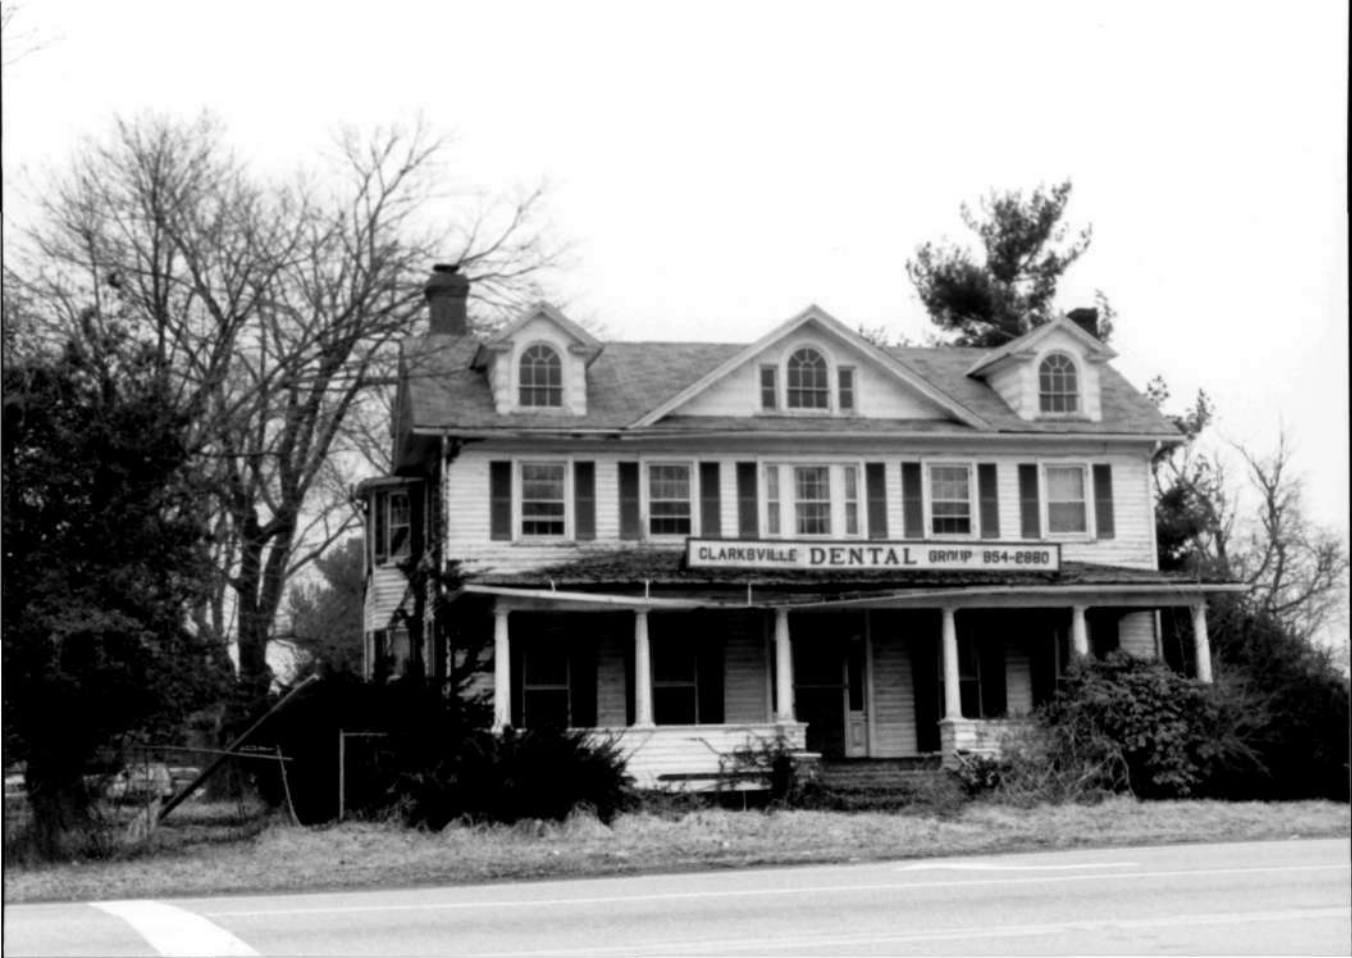
2/9

East elevation

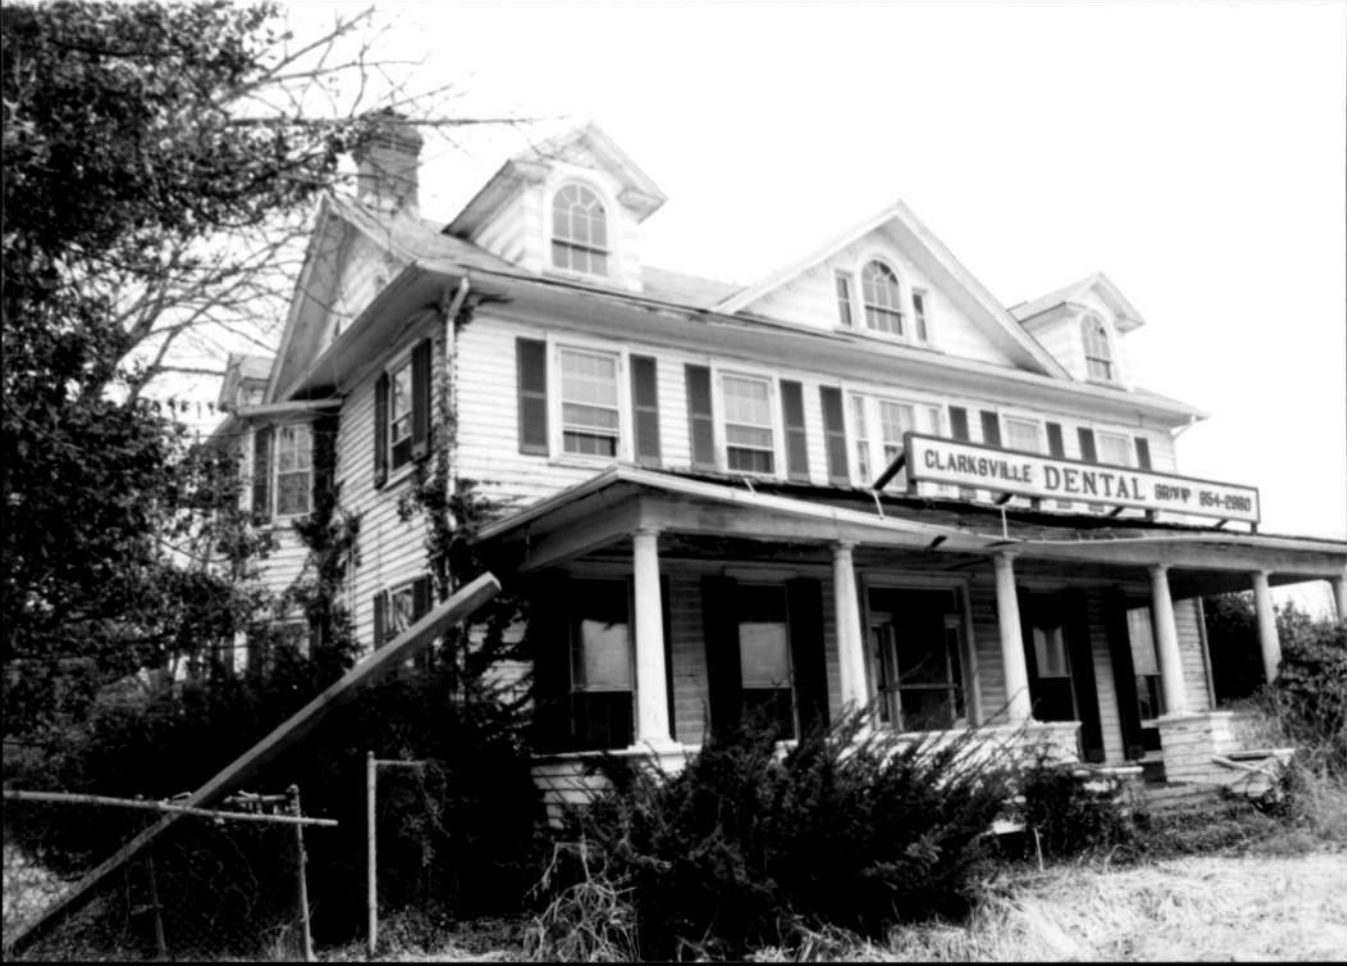
4/9

Front (east) elevation

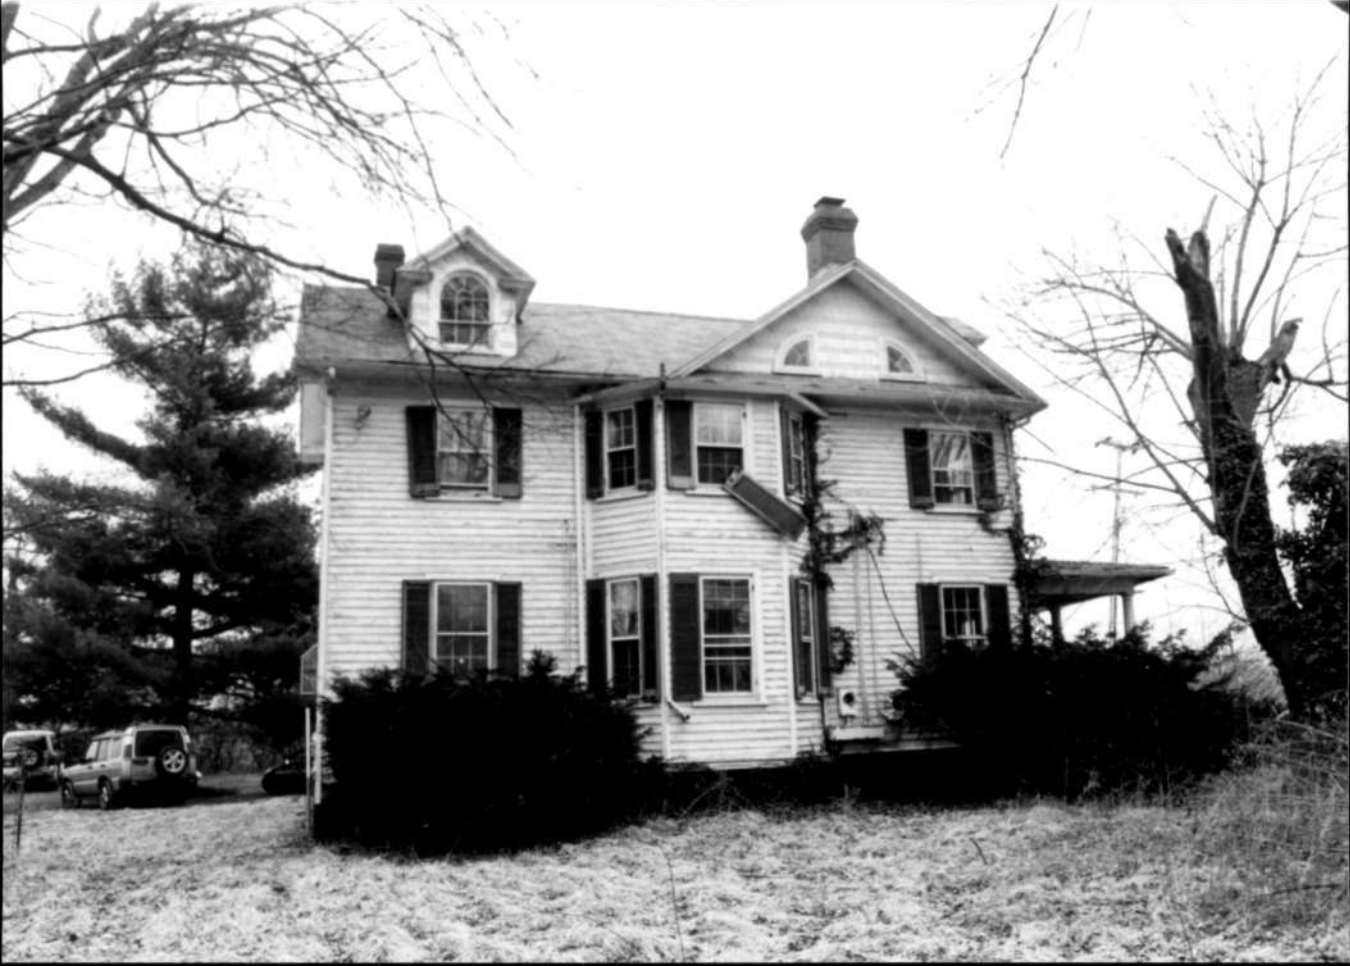
5/9

The south side façade of the house features a three sided, two story bay window centered on the wall. The sides of the bay window hold 4/4 double hung wood windows while the center bay holds 6/6 double hung windows on each story. In front of the bay window, there is one 6/6 double hung window on each story and towards the rear of the house, behind the bay window, there are two more 6/6 windows, one on each story. The gable end of the side gabled section is pedimented and shingled and holds two half fanlights flanking the chimney stack. The west slope of the roof of the rear wing holds another dormer window. The dormer holds an arched window matching the ones on the front façade.

South elevation

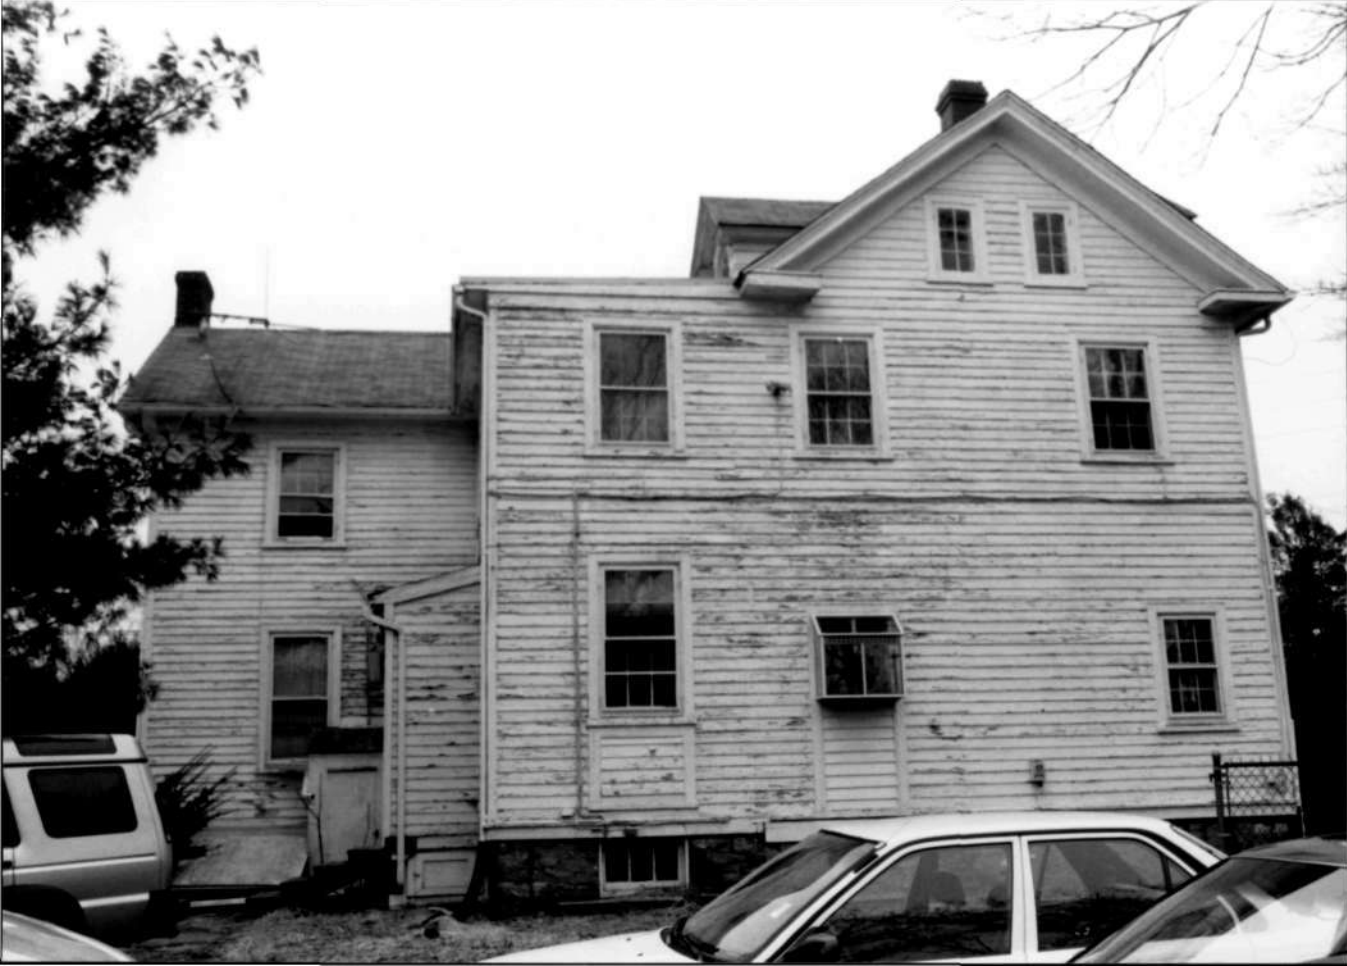
6/9

On the rear façade, the gabled roof of the rear wing covers the two south most bays and a nearly flat shed roof covers the single north bay. At first glance, this two story, shed roofed section on the north side of the rear wing appears to be an addition, but the stone foundation shows no evidence of a seam. The rear façade of the gabled wing and the shed roofed section has three windows across the second story, all of which are 6/6 double hung wood windows. The first story has seen several alterations and the middle bay on the first story was originally occupied by a door and an entry portico. Now that bay holds a small greenhouse-type window and the porch has been removed. The left most bay on the first story also appears to have originally held a door that has since been replaced by a 6/6 window. The right-most bay on the first story holds a small 6/6 window. The gable end of the rear wing has cornice returns and two six-light casement windows. One three-light window is located in the foundation. The rear wing does not span the full width of the side gabled section and the portion of the rear façade of that section that is visible holds one 6/6 window on each story.

Rear (west) elevation

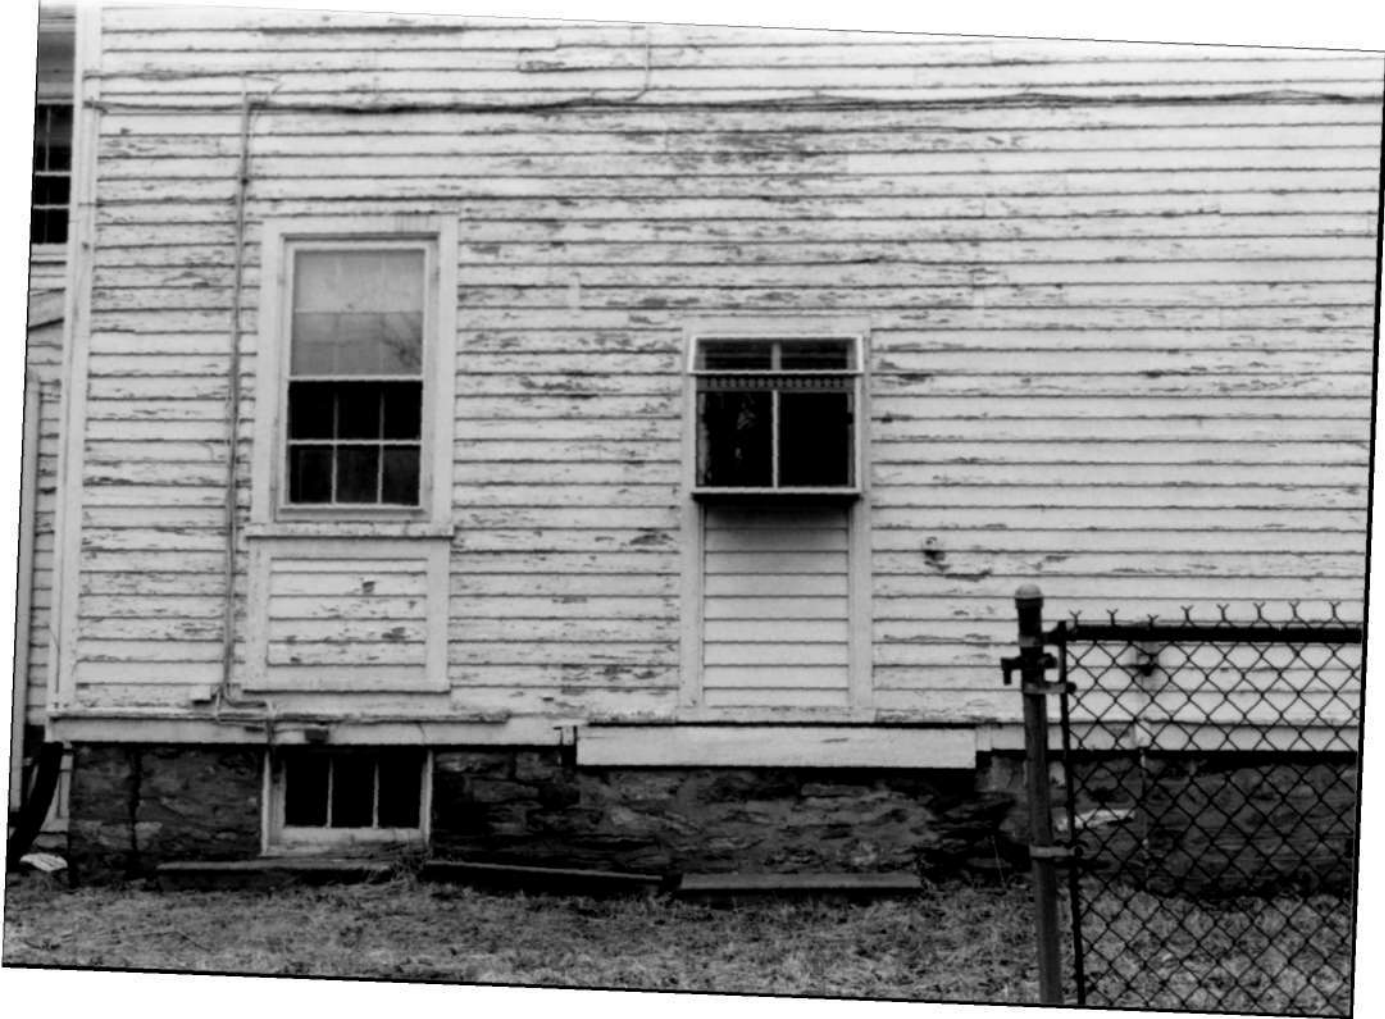
7/9

detail of closed doorways + removed portico on
west (rear) facade

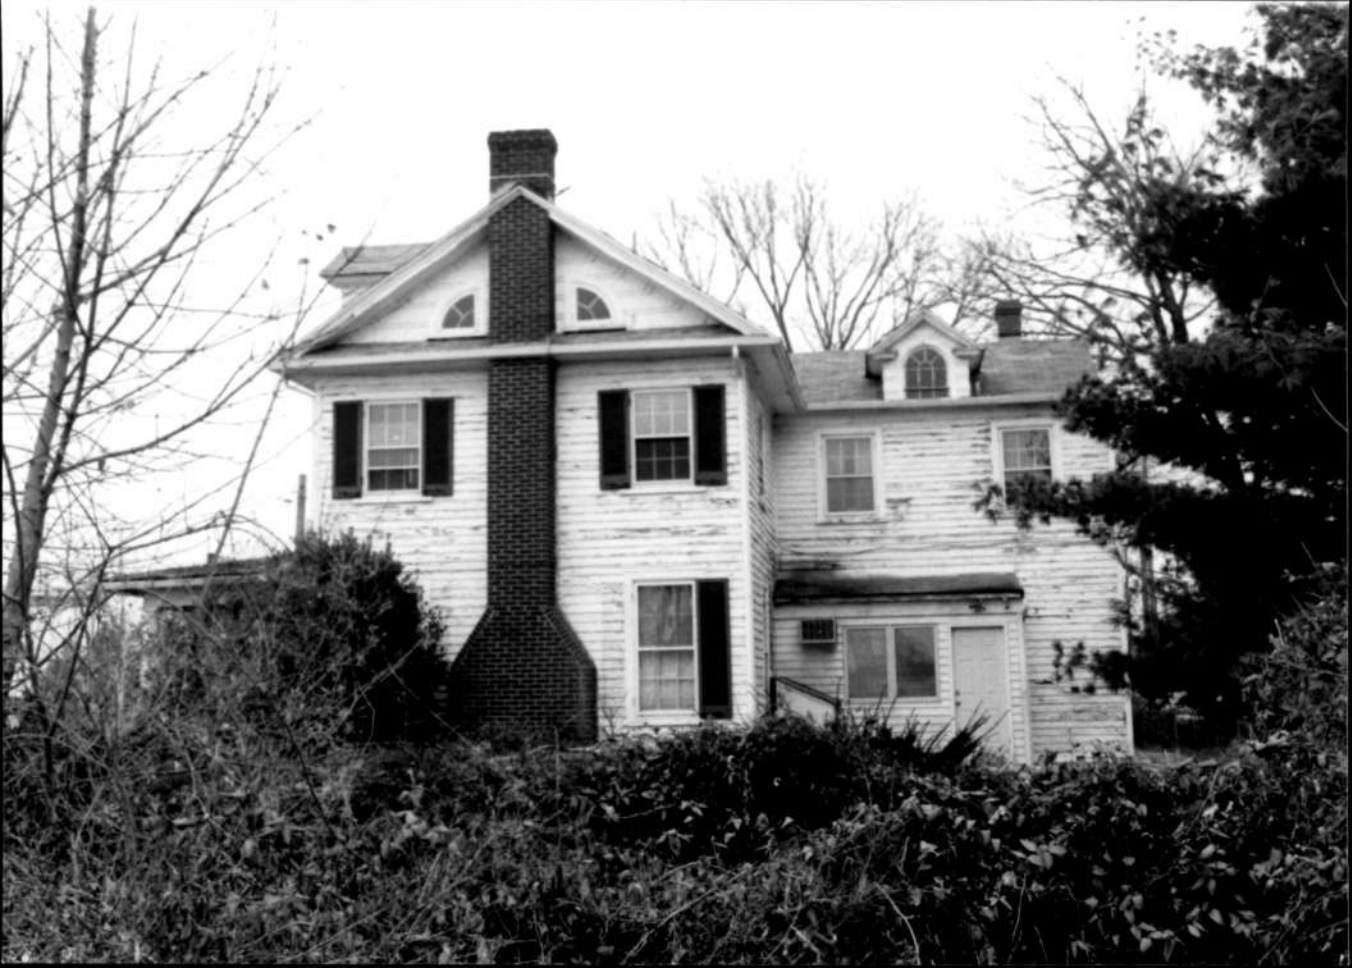
8/9

The north side façade of the front, side gabled section holds two 6/6 double hung windows on the second floor vertically aligned above two more 6/6 windows on the first floor. The windows flank the exterior brick chimney that is centered on this wall. Two half fanlight windows located in the pedimented, shingled gable also flank the chimney, as do two three-light windows located in the foundation. The north elevation of the rear wing features two 6/6 windows on the second floor and a gabled dormer matching the others in the house is found on the north slope of the gabled part of the rear wing. The first story of the north façade of the wing is covered by an enclosed porch with a recent aluminum door.

North facade

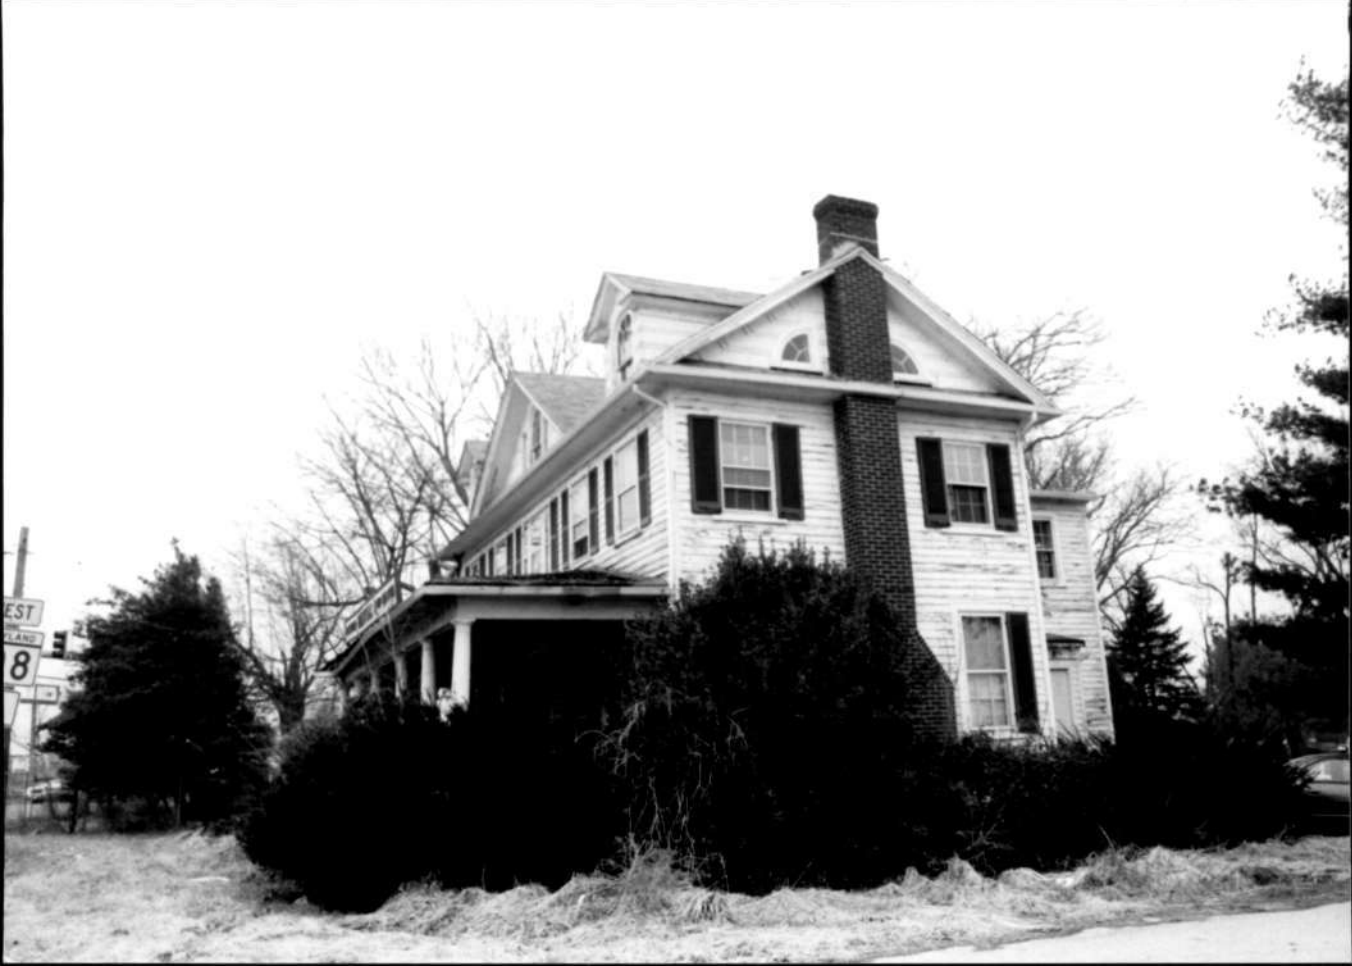
9/9

NE elevation
